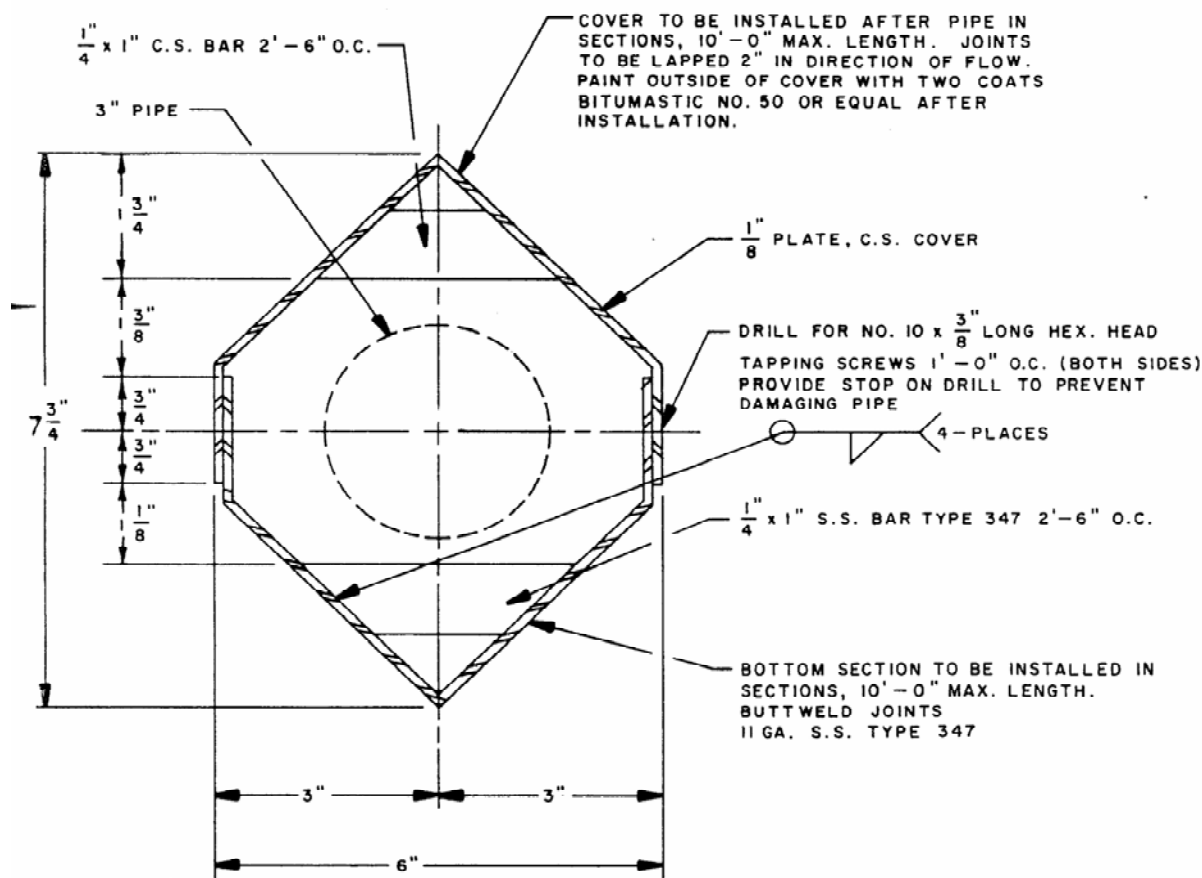
**5.9.1.1 Background of System Configuration and Leak.** In 1955, a major expansion project at INTEC (known as the ICPP at the time) installed three new 300,000-gal storage tanks (WM-182, WM-183, and WM-184) and associated waste transfer lines in the tank farm. Portions of two transfer lines, PUA-1005 and PUA-1030, were equipped with a split steel encasement of inferior design. The encasement consisted of a lower trough section constructed of welded stainless steel in which the transfer line was supported. The upper, cover portion of the encasement was made of carbon-steel painted with two coats of bitumastic paint. The upper portion was lapped and pinned to the lower stainless-steel trough by means of screws spaced on 1-ft centers along each side of the encasement near the centerline of the waste transfer pipe (see Figure 5-19 and INTEC Drawing 105585, Rev. 3). The screws were inserted through holes that were drilled through the encasement after the transfer line and encasement were set in place in the field. The design called for the use of a stop when drilling the encasement pilot holes to prevent damage to the waste transfer pipe inside the encasement (see note on Figure 5-19). However, despite the cautionary notes in the system design, one of the encasement screw holes went through waste transfer pipe PUA-1005, leaving a hole in the line.

Although waste transfer line PUA-1005 had a hole for nearly 20 years of use, the soil contamination at CPP-28 likely occurred in the early 1970s, after the failure of the upper portion of the encasement. Soil contamination did not occur throughout the 20 years of service of the waste transfer line. The original contamination investigation report concluded leaks likely did not occur during most waste transfers. The waste transfer system was a low-flow, gravity-drain system that seldom filled the pipe above the level of the hole. Even if waste leaked from the primary waste transfer line, soil contamination did not occur immediately because the lower trough portion of the encasement was constructed of welded stainless steel and conducted any leakage to the sump of a nearby tank vault. Soil contamination did not occur until the upper, carbon-steel portion of the encasement failed, which allowed soil to enter the encasement and block the drainage path for the leaking liquid. This resulted in subsequent soil contamination. The upper portion of the encasement was not in direct contact with the leaking waste and was coated to prevent corrosion from the soil. It likely lasted many years before failing.

Figure 5-19. Cross section of the original (1955) design of Line 3"PUA 1005 with its split steel secondary encasement (taken from INTEC Drawing 105585, Rev. 3).

After the leak was discovered in 1974, the two lines with the split carbon/stainless-steel encasement were removed and replaced with a system having welded, stainless-steel, pipe-in-pipe encasement.

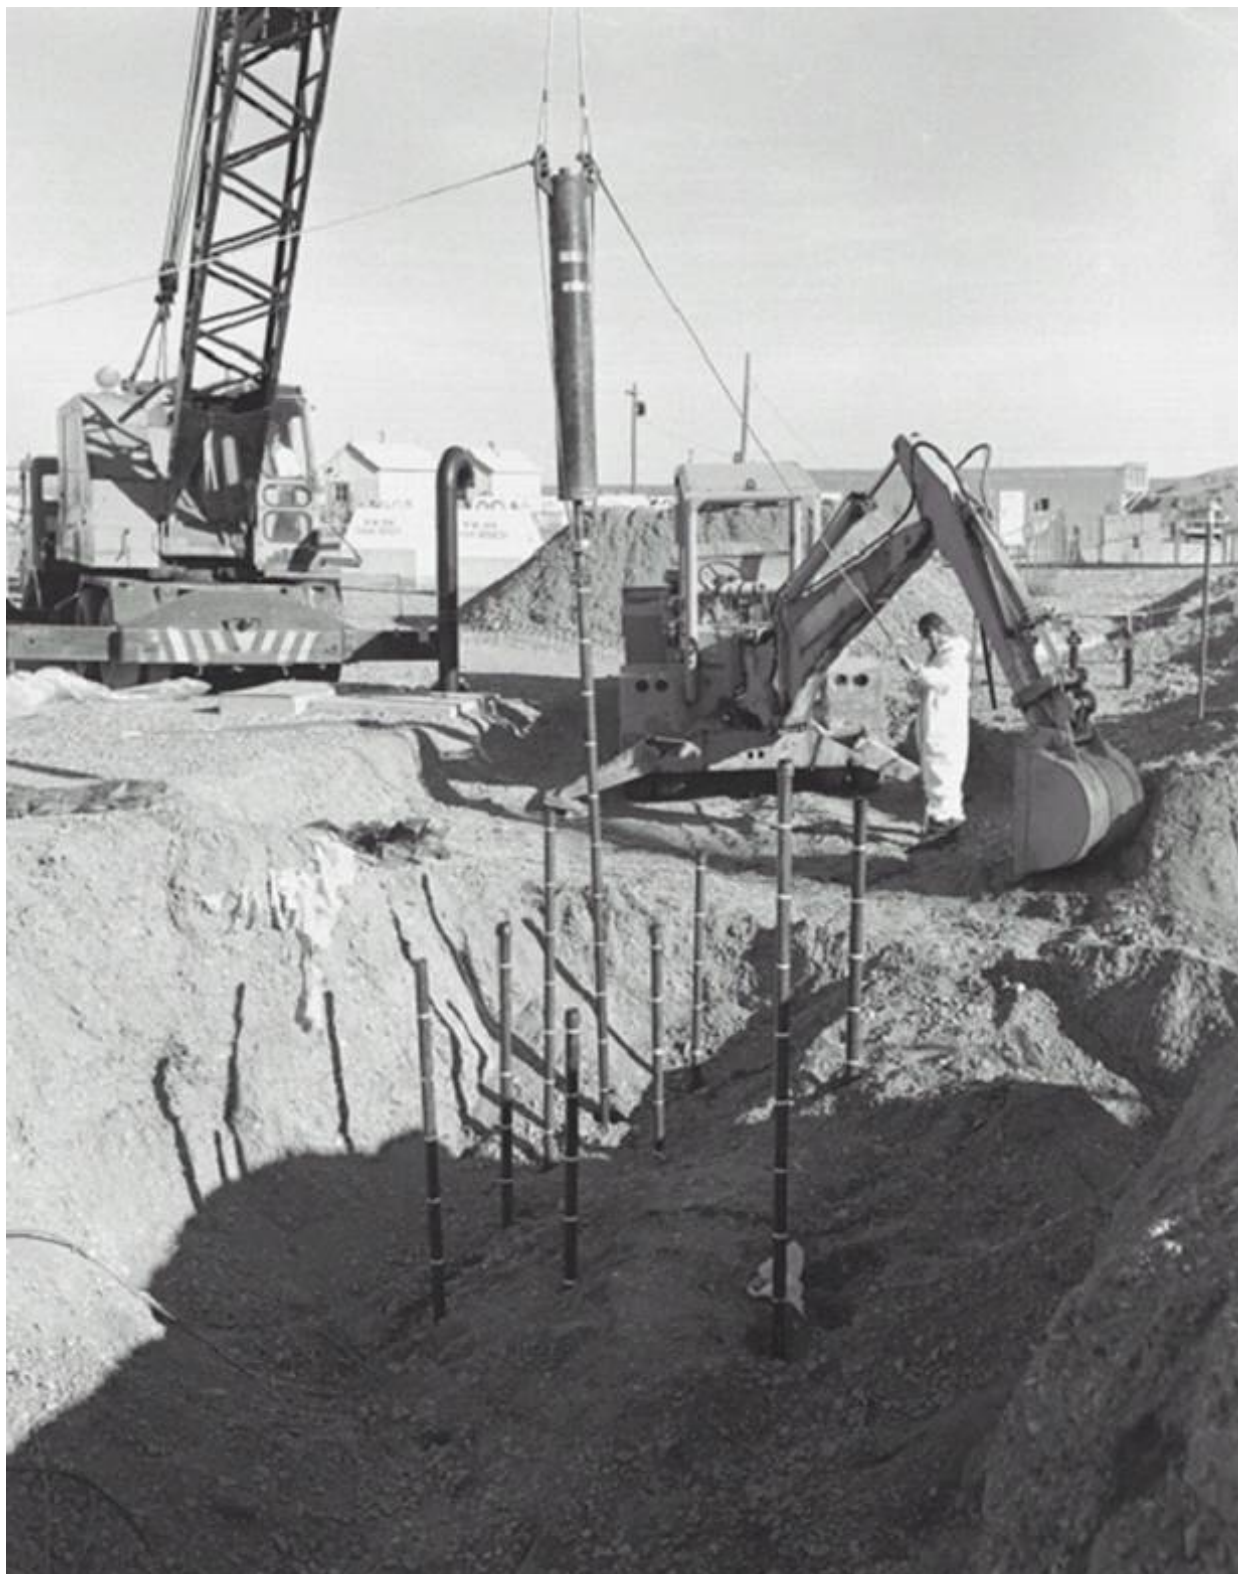
After trenching operations were completed, monitoring test pipes were driven into the ground using a cable crane rig outfitted with a 750-lb drive shoe (Figure 5-21). Test pipes were driven in 11 locations adjacent to the pipeline encasement and in the area of soil contamination to depths up to 20 ft, as shown in Figure 5-21. After each test pipe was driven, a radiation-detection probe was lowered into the test pipe, and radiation readings were measured at specific depth intervals. Recorded radiation readings collected from the test pipes are presented in Table 5-27.

Figure 5-21. Test pipes being driven into the ground during the contaminant release investigation in 1974 at CPP-28.

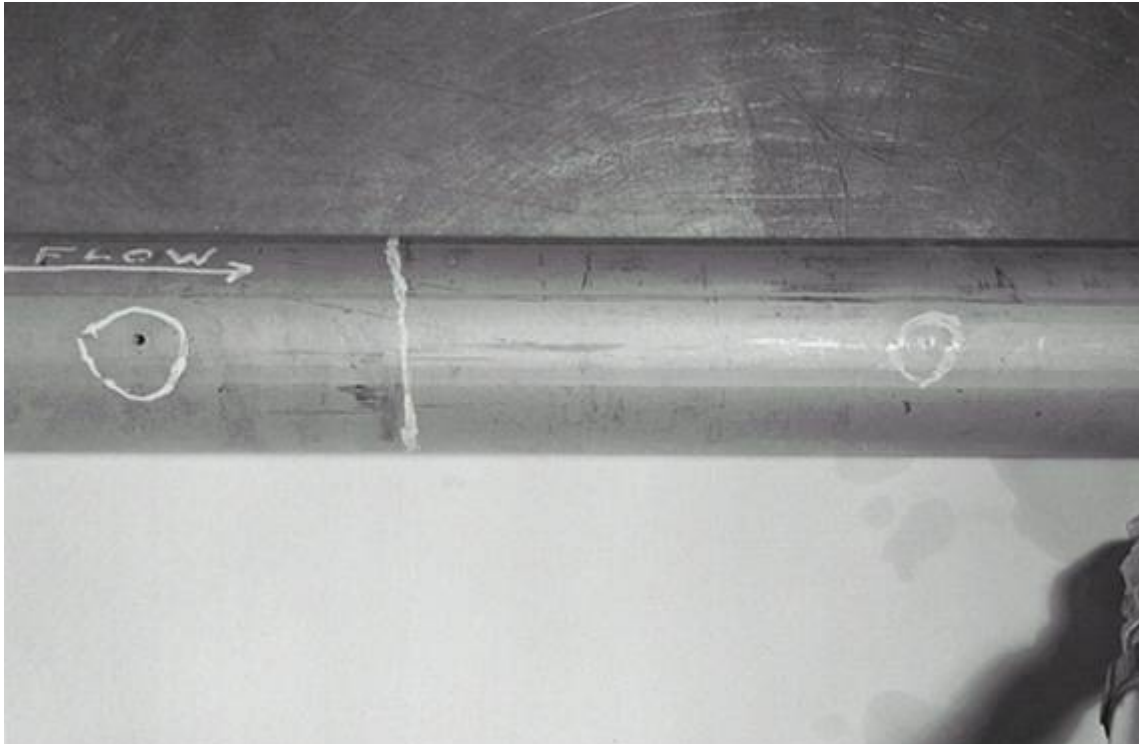
On December 3, 1974, work began to cut, remove, and inspect the 20-ft section of the waste transfer line to determine the cause of the contamination. After removal of the pipe section, a cursory inspection revealed a 1/8-in.-diameter drill hole in the side of the 3-in. stainless-steel pipe (Figure 5-22). After closer inspection, the hole in the pipe was determined to be 10 ft, 7 in. from the east pipe cut and oriented 90 degrees from the top of the pipe on the south side as originally installed. This location

Figure 5-22. Drill hole found in waste transfer line 3"PUA-1005 at CPP-28.

corresponded closely with the location of the corroded area of the upper section of carbon-steel encasement observed in the field. The hole penetrated completely through the pipe wall, and small indents 40 to 50 mils deep existed along the pipe on 1-ft centers eastward from the hole. No holes or indents were found on the opposite (north) side of the pipe. The hole and indents were consistent with the stitch screw spacing used to hold the top cover of the encasement to the bottom trough. A metallurgical inspection indicated that the pipe suffered very little corrosion damage during its 18 years of intermittent service and that the failure was strictly due to a hole that had existed when it was inadvertently drilled into the waste line during construction from 1955 to 1956.

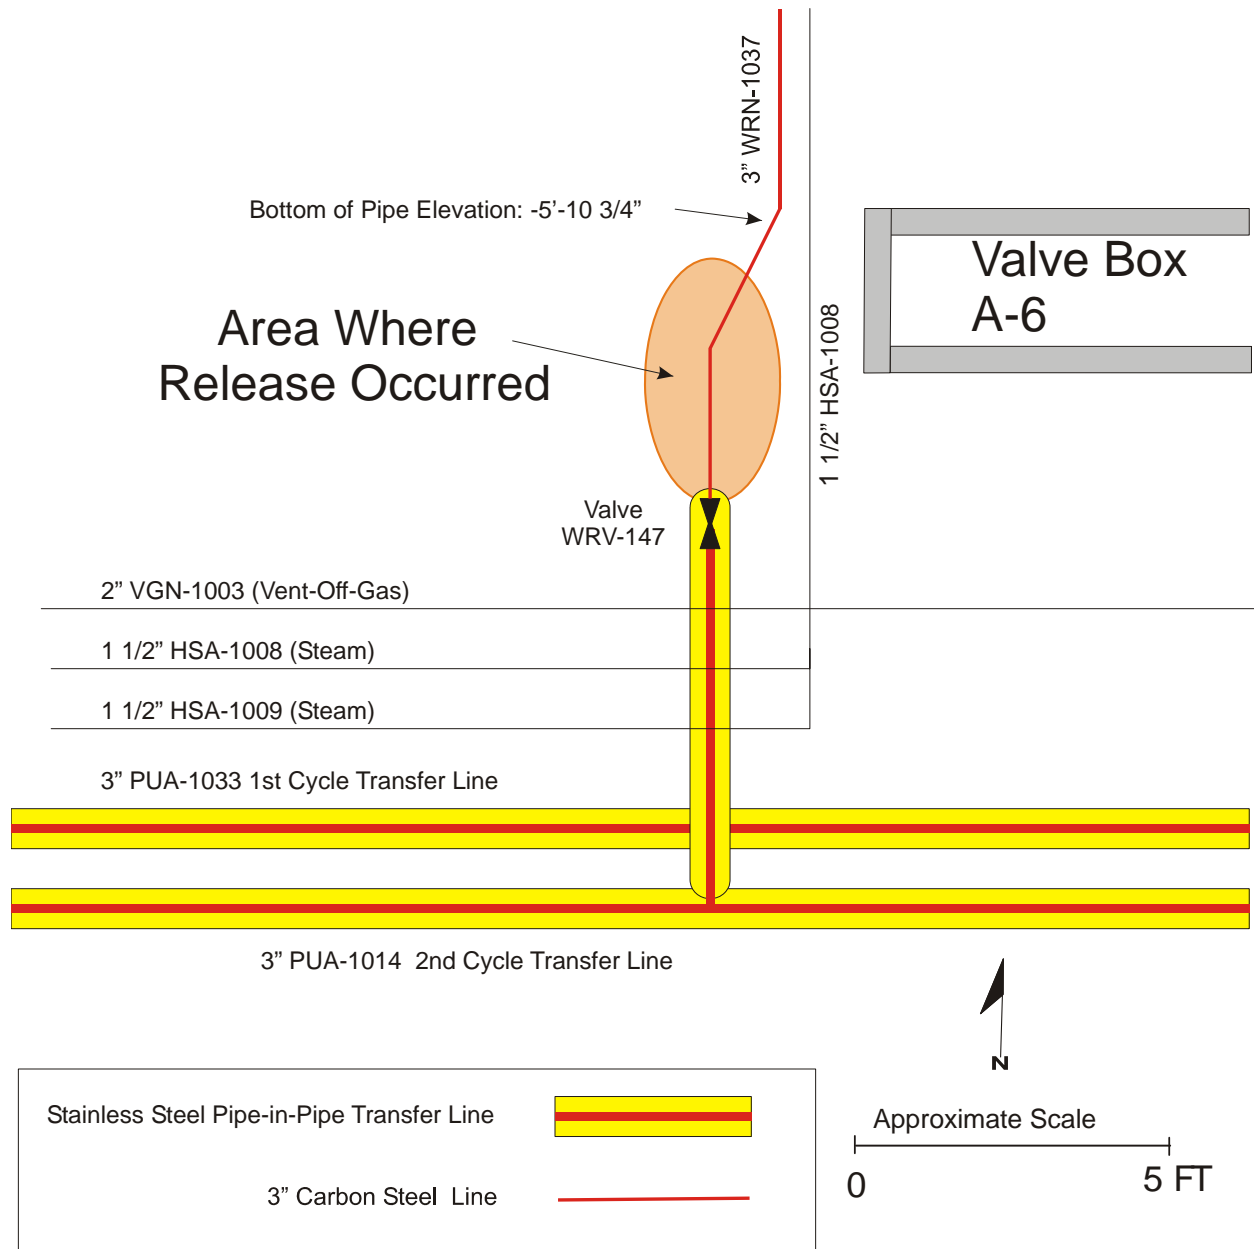
**5.11.1.1 Background of System Configuration and Leak.** In 1957, a tank farm expansion project installed two 300,000-gal storage tanks (WM-185 and WM-186). This project also installed a waste transfer piping system that could remove waste from the tanks and transfer it to other tanks or to the (future) WCF. The waste transfer piping included Line WRN-1037 that connected the tank farm cooling water system located in CPP-628 to the SBW transfer line PUA-1014. Line WRN-1037 was to have been used if the tank farm cooling water became contaminated due to the failure of a cooling coil in one of the tanks. The line provided a disposal path for the contaminated cooling water. Because the tank cooling water was not acidic and failure of a cooling coil and contamination of the cooling water was an unlikely event, most of the Line WRN-1037 was constructed of carbon steel and did not have any secondary encasement. Line WRN-1037 changed to a stainless-steel, pipe-in-pipe, encased line a few feet from its connection to the stainless-steel, SBW transfer line PUA-1014. A single valve (WRV-147) isolated the carbon-steel cooling water disposal line from the stainless-steel SBW waste line at the material transition point. Figure 5-27 shows the piping configuration near the location of the release.

In November 1972, the SBW in WM-181 was transferred to WM-180. WM-181 was emptied in order to serve as a temporary service waste diversion tank until a permanent diversion tank (WM-191) was constructed. The transfer of waste from WM-181 to WM-180 used Line PUA-1014, which was connected to the tank farm cooling water disposal line. The investigation report indicates the isolation valve (WRV-147) on the cooling water disposal line either leaked or was not fully closed during the waste transfer. This allowed SBW to enter the carbon-steel portion of Line WRN-1037, which failed rapidly in the acidic waste. The waste leaked from the failed line directly into the soil because there was no secondary containment around the failed carbon-steel portion of the line.

Figure 5-27. Plan view of the piping configuration at the CPP-31 release site.

Following the discovery of the source of the leak, Line WRN-1037 was cut and capped, and Line PUA-1014 restored to normal service.

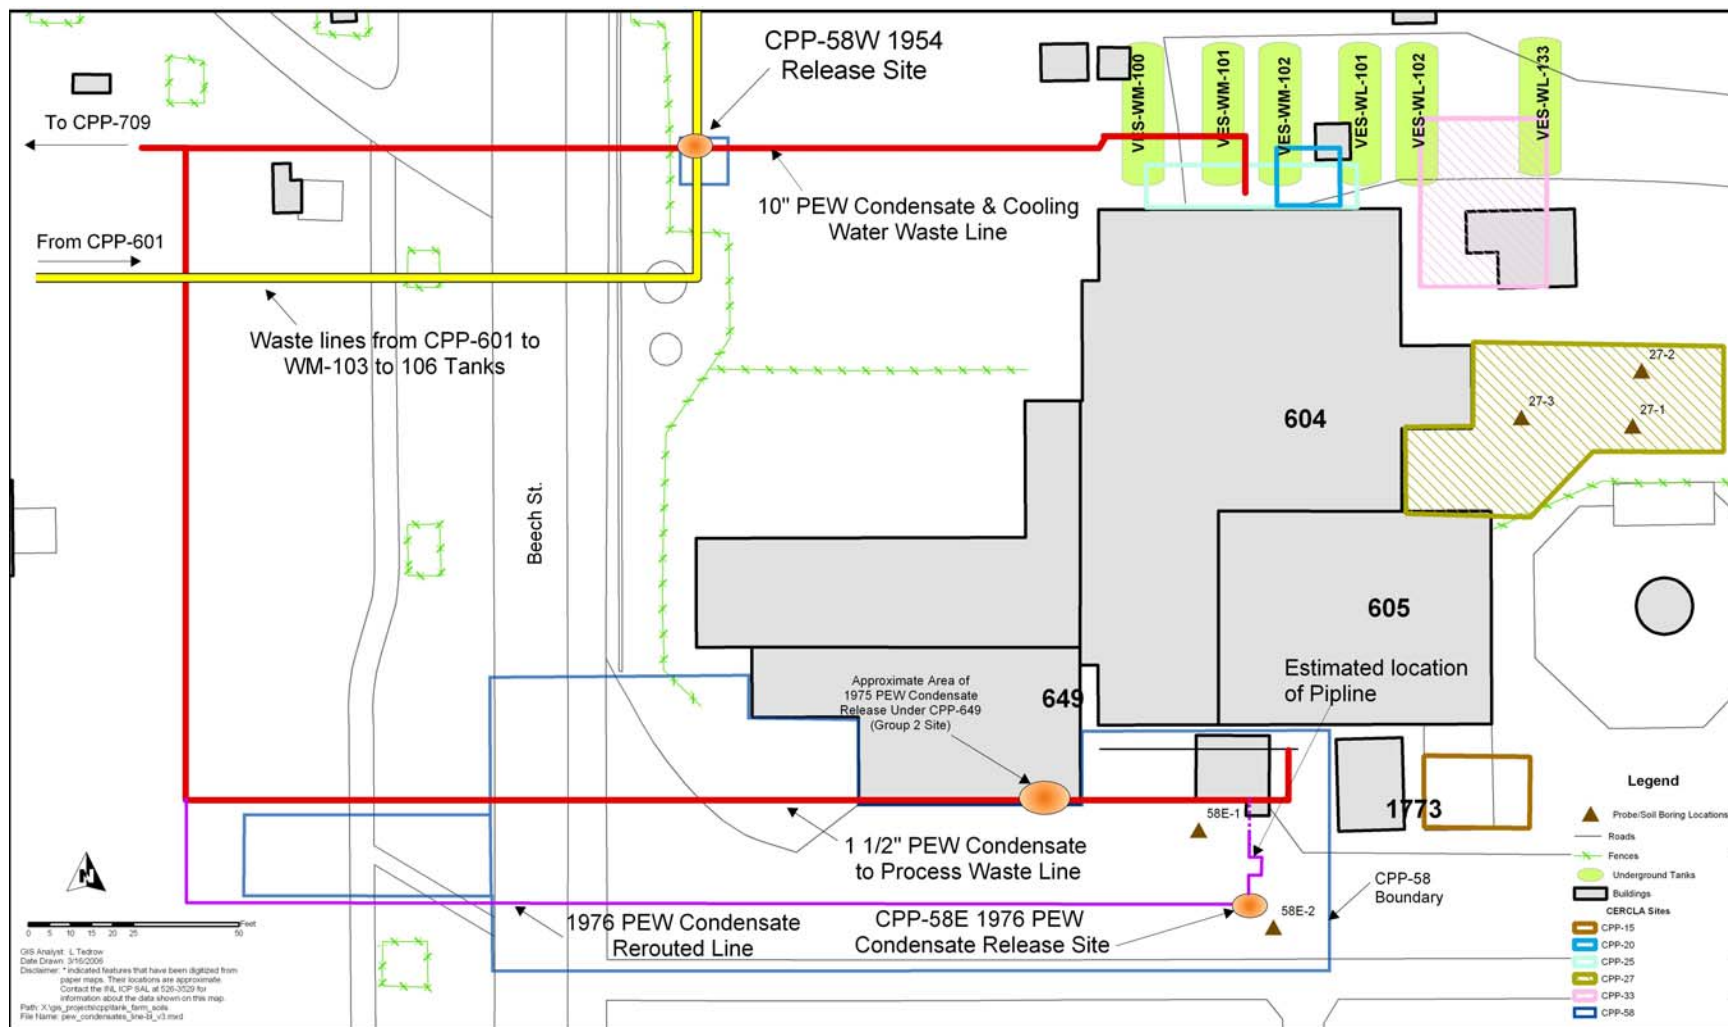
In September 1976, a leak occurred (CPP-58E) when an elbow in the evaporator condensate line PLA-2069 failed. The failure point was as a result of piping changes made in 1975 to reroute a line when it failed the year before. The 1976 failure was attributed to thermal stress. The line was rerouted to relieve the stress, repaired, and returned to service.

Another leak from underground line PLA-2069 occurred in Site CPP-58 in October 1977, based upon information in Operations monthly reports. The leak was west of Beech Street at an elbow in Line PLW-2069 where the line turns from a westerly to a northerly direction (see Figure 5-38). At the time, Line PLA-2069 was used to transfer PEW evaporator condensate from CPP-604 to the service waste system. The leak was discovered when leaking liquid was observed seeping through the surface of the soil. An excavation revealed a failed elbow in Line PLA-2069. The line was repaired and the system was returned to service.

Figure 5-39. Map showing location of release site CPP-58, piping, and leak location.

A third leak from underground line PLA-2069 occurred in Site CPP-58 on August 19, 1980. The leak was just east of Beech Street and north of Olive Avenue. At the time, Line PLA-2069 was used to transfer PEW evaporator condensate from CPP-604 to the service waste system. The leak was discovered when leaking liquid was observed seeping through the surface of the soil. PEW evaporator condensate was being pumped from Vessel WL-106 to service waste at the time of the leak. After stopping the waste transfer, liquid stopped seeping out of the ground and the liquid that had accumulated on the soil surface immediately sank into the ground. An excavation revealed a failed elbow in Line PLA-2069. The elbow failed due to thermal stress. The line was repaired in a manner to reduce future thermal stresses and the system was returned to service.

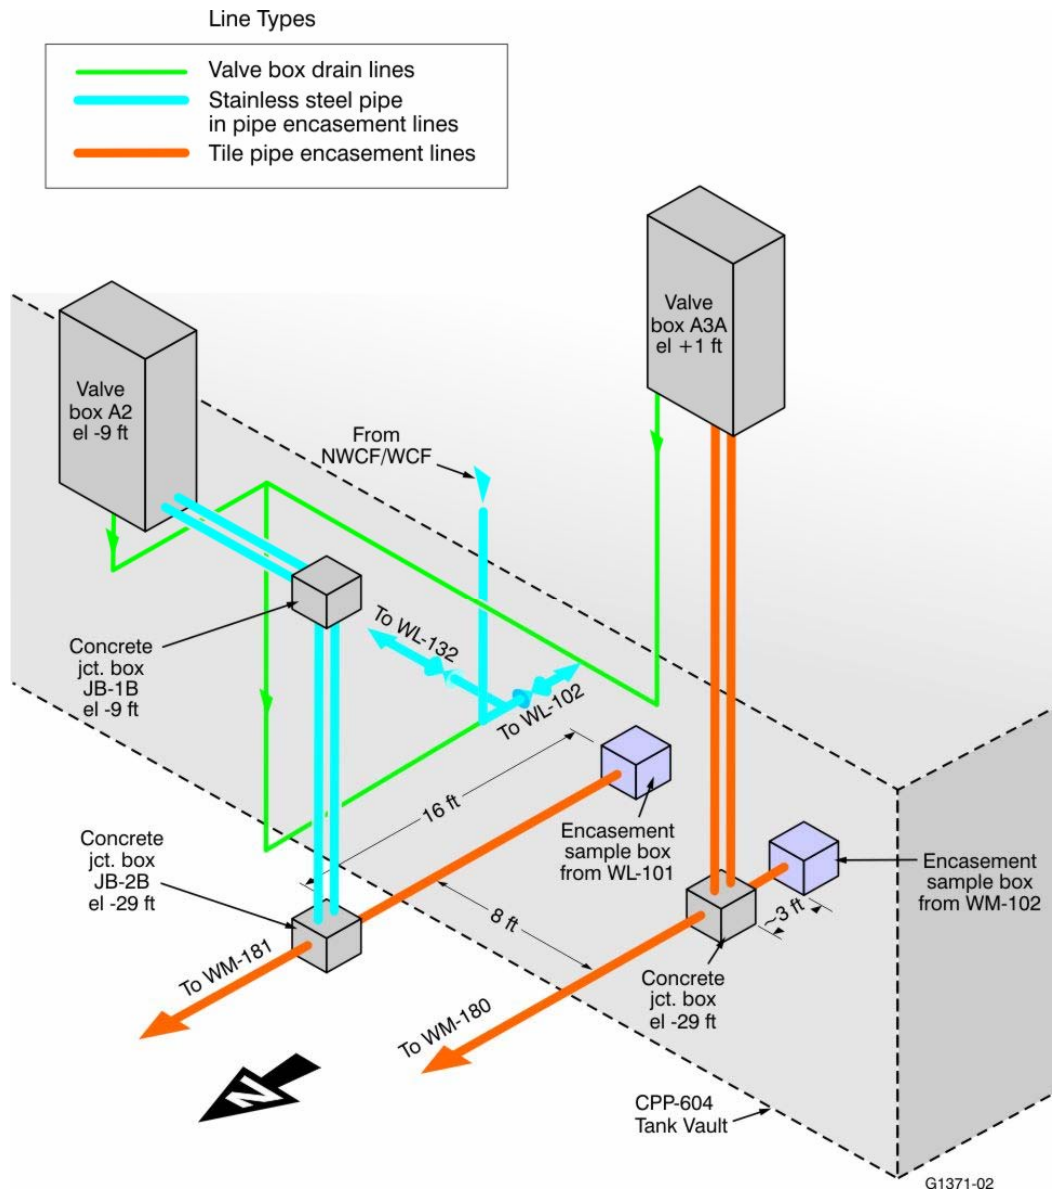
During waste transfers from the New Waste Calcining Facility (NWCF) and WCF, two closed valves caused waste solution to back up into Valve Box A2 via the valve box drain line. The waste flowed out of Valve Box A2 via the encasements surrounding transfer lines PUA-1013 and PUA-203 that entered the west side of Valve Box A2. The waste leaked to the soil through failed encasements. The exact location of the encasement failure was never determined. The pipe encasements included sections of stainless-steel pipe, split tile pipe, and two unlined/unsealed concrete junction boxes. The stainless-steel pipe-in-pipe encasement and one of the junction boxes were at an elevation about 9 ft below grade (not including the elevation of the berm north of CPP-604), which was just above the CPP-79 (shallow) contamination. The second junction box and the split tile portion of the encasement were about 29 ft below grade, which was just above the CPP-79 (deep) contamination site. The vertical piping between the upper and lower piping sections was encased in stainless-steel pipe-in-pipe encasement.

Figure 5-41. Schematic showing the configuration of waste transfer piping and valve boxes near the CPP-604 tank vault associated with Site CPP-79 contamination.

The portions of encasement most likely to leak were the concrete junction boxes and the split tile encasement. The tile encasement was originally installed in the early 1950s. It was excavated in the mid-1950s and modified by the installation of the lower concrete junction box. The piping inside the new junction box was modified to provide a route to the new (at the time) Valve Box A2. The excavation, modification, backfilling, and subsequent soil settling could have damaged the brittle tile encasement (or concrete junction boxes), resulting in leakage to the soil in 1986. The waste transfer lines whose encasements leaked (PUA-1013 and -203) were administratively removed from service at the time of the leak, which prevented additional soil contamination. The lines were physically removed during a tank farm upgrade project in the mid-1990s.
